# Report 40850R24 Revision 1

## Final Technical Report

### Demonstration of Black Liquor Gasification at Big Island

DOE Award Number: **DE-FC22-01NT40850**

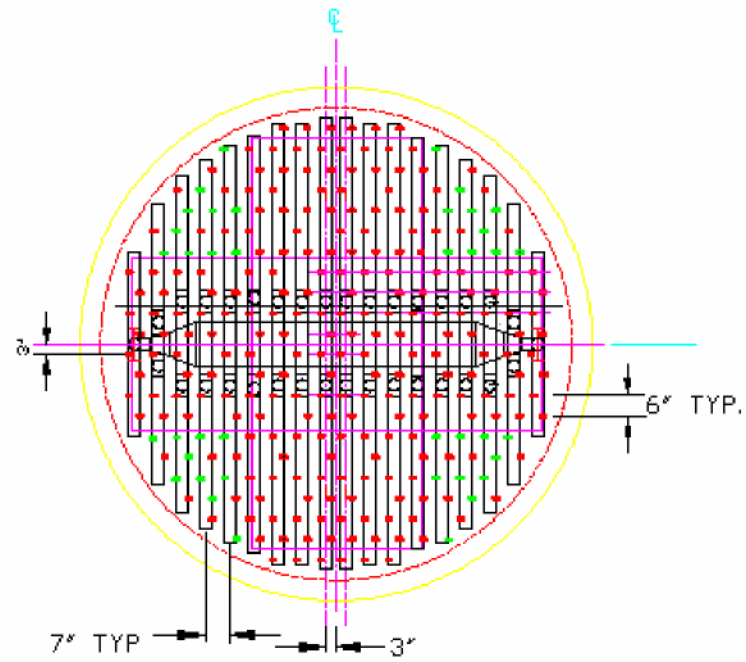
**GRID GP-4**

At the end of last period, run 11 was completed. At the end of run 11 a steam-out trial was conducted and data was collected and analyzed. During this reporting period, three trials were conducted using Reformer 2. During all three trials, the reformer was operated with only 3 heaters in service. The fourth heater had been removed and shipped to Mitternacht for tubing replacement. The fluidizing grid in Reformer 2 was modified to the configuration of Grid GP-4.
